City of Somerville — RFP nº 12-71

ADA Self-Evaluation (as basis for Transition Plan)

Prepared by
Institute for Human Centered Design
August 12, 2013

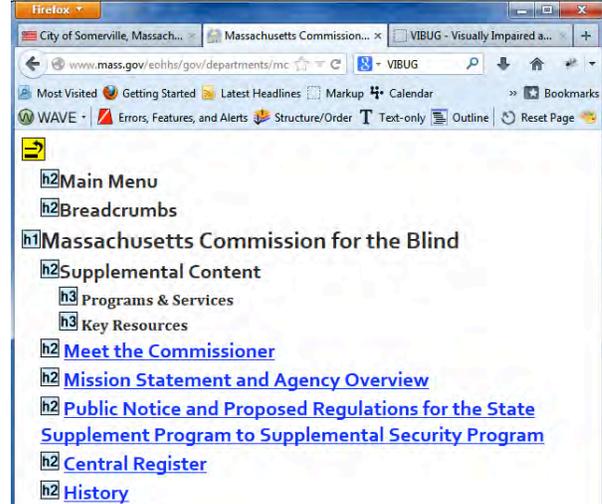
Mass.gov

- 3) The 'MA' in Somerville MA offer poor contrast and was not discernible for user/expert with low vision

- 4) The vertical text on the Menu 'HOME' 'DEPARTMENT' 'RESIDENT' 'BUSINESSES' are difficult to read for most users, vertically placed text is not recommended for readability, and the use of all Capital letters in title make it harder to read.
- 5) The page has no "skip navigation links" that would allow the user to jump to the main content. To ease navigation, place a skip navigation link near the top of the page anchored to the main page content.
- 6) The black arrow to navigate through the image at the bottom is not sufficiently obvious. None of the users realized that there was more content to be explored. A possible solution would be to place bigger arrows on both sides of the horizontal menu

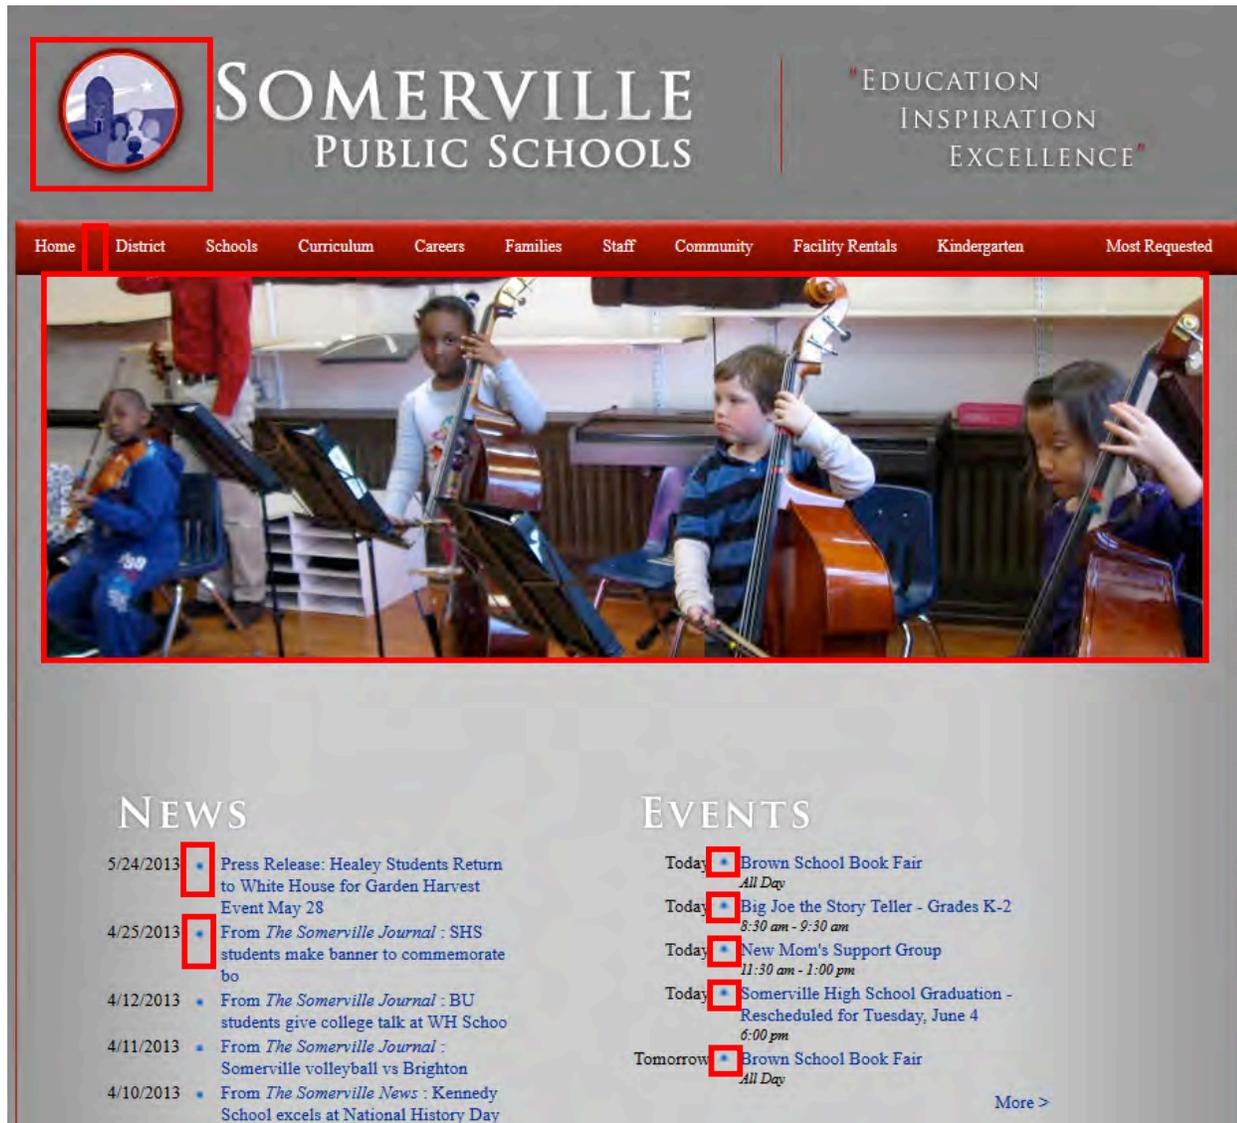
- 1) No headings.
- 2) None of the images on the slider was provided an Alternative Text. A lot of the information (calendar; info) is provided by image that don't have Alternative Text
- 3) Every bullet is an image and reads to the screen reader as if there is content. Should be null text here.

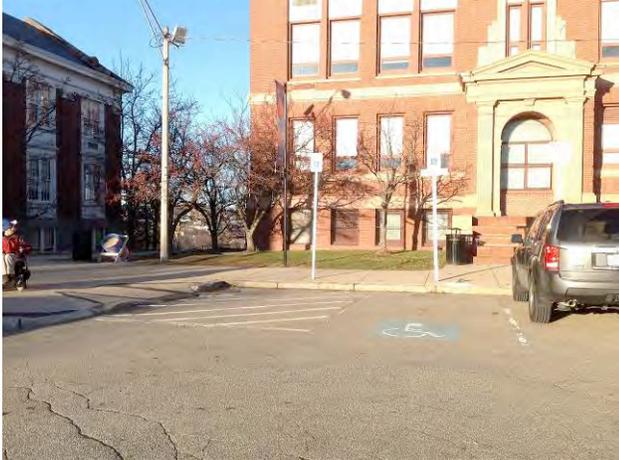
Photo 1

Exterior sidewalk access to City Hall is problematic because of non-compliant curb ramps and sidewalks with deteriorated surface that can become tripping hazards to the public and staff. At the accessible parking space closest to both City Hall and the High School, the curb ramp and sidewalk have eroded and there is a 1-2" lip as it joins the access aisle. (Photo 1)

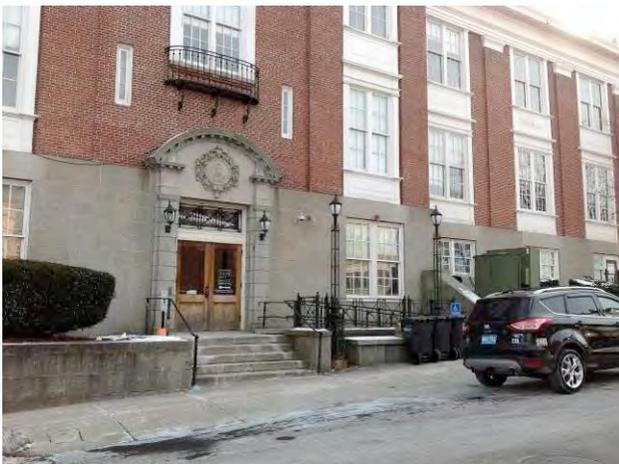
Photo 2

The building has entrances on two sides – on School Street and along the parking lot next to the High School. Both entrances are accessible via ramps, although the ramp on School Street has surface and handrail issues. (Photos 2 and 3)

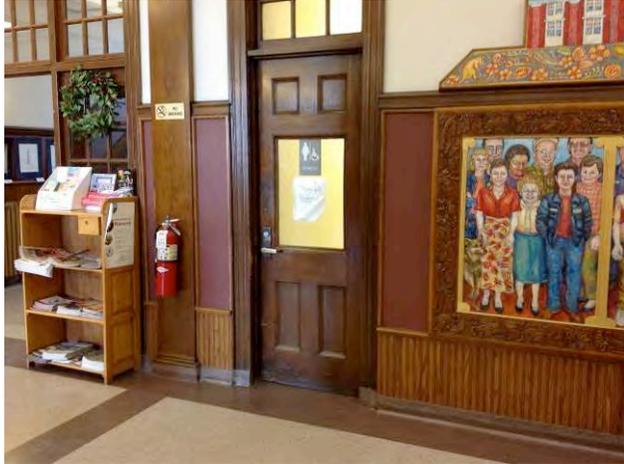
Photo 4

- Some doors to public spaces and offices do not have the minimum clear width for accessible doors;
- A few doors have inaccessible hardware or locks;
- Several single- and double-leaf doors exceed the maximum allowable force required to open them;
- Numerous doors have non-compliant hardware and do not have the minimum maneuvering clearance required to open them. (Photo 4)

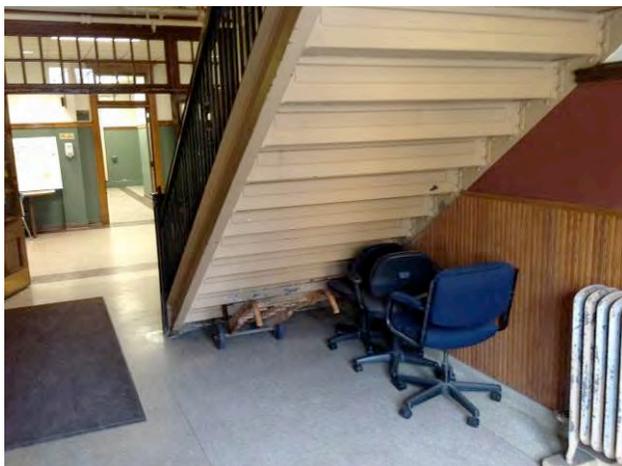
Photo 6

Hazardous protruding objects, such as the unprotected underside of the stairway and the wall-mounted shelf near the exterior doors, were found on the School Street entrance. These protruding objects increase the likelihood of injuries among people with low or no vision or others who may be unobservant. (Photo 6)

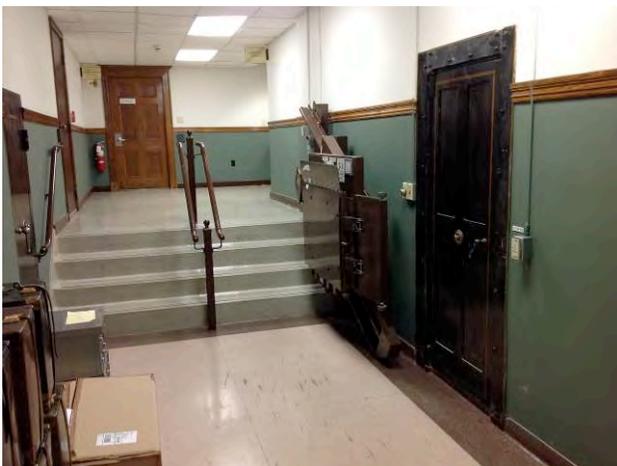
Photo 9

On the basement level, an internal stairway with non-compliant handrails leads to the Constituent Services 311 office and Office of Communications and TV Cable. (Photo 9)

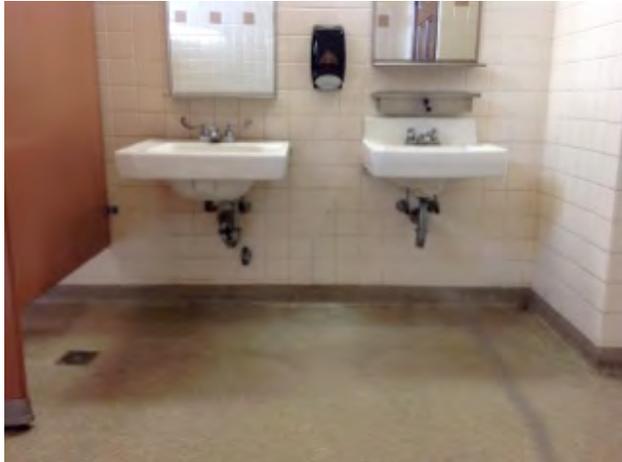
Photo 13

In both single-user toilet room on the basement level, faucets are non-compliant, plumbing underneath lavatories is not protected, grab bars do not meet the minimum allowable height, and curbs on one of more sides of toilet obstructs the clearance of the fixture.

Additionally, one inaccessible toilet room for female staff use is located on the first floor. (Photos 13, 14, and 15)

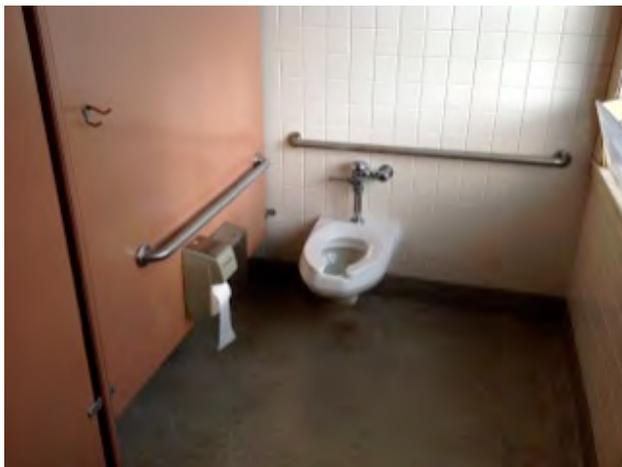
Photo 14

In both multi-user toilet rooms on the second floor, plumbing underneath lavatories is not protected. In the men’s toilet room, an accessible urinal is not provided, the radiator inside the toilet stall encroaches the clearance of the stall, and the wall-mounted paper towel dispenser behind the door obstructs the swing of the door. In the women’s toilet rooms, the flush control of the toilet is mounted on the incorrect side and the side grab bar does not meet the minimum allowable height inside the accessible toilet stall.

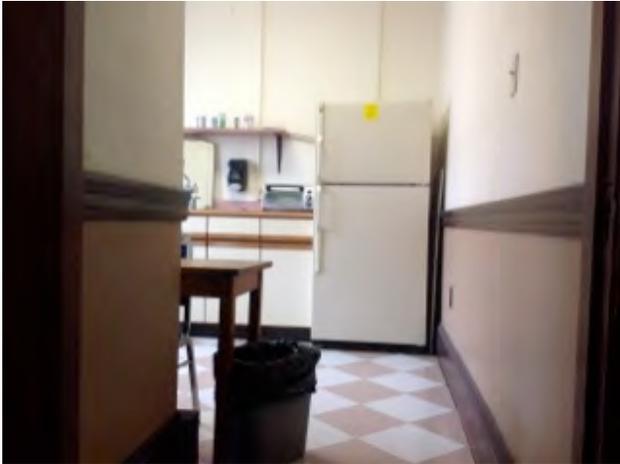
Photo 16

On the basement level, the kitchenette has not been renovated and lacks clear floor space and an accessible sink, among other items. (Photos 16 and 17)

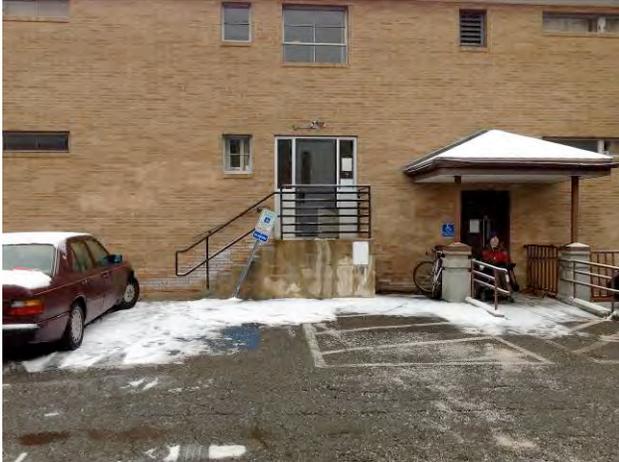
Photo 1

Off-street staff and public parking is offered in parking lot adjacent to the building. One accessible van parking space for public or staff was identified near the vertical lift and the rear entrance. The sign that identifies the accessible parking space is damaged. (Photo 1) No drop-off area was identified in this facility.

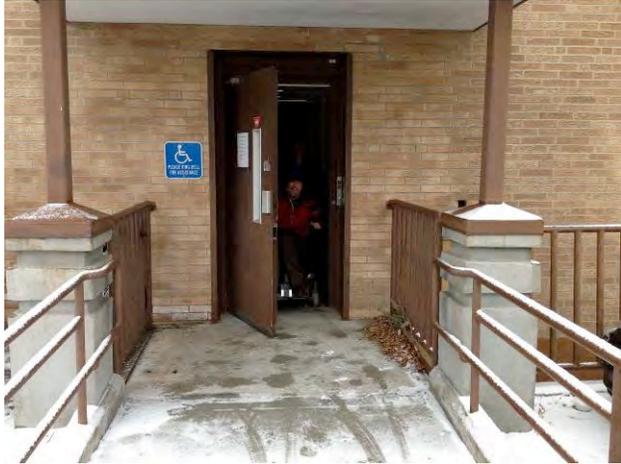
Photo 4

A non-compliant limited-use/ limited access elevator with an expired certificate for use is provided near the rear entrance. This elevator cannot be independently operated by customers as a key is required to unlock the device. A sign with the words 'please ring bell for assistance' is located at this entrance along with the buzzer used to alert the staff. (Photo 4)

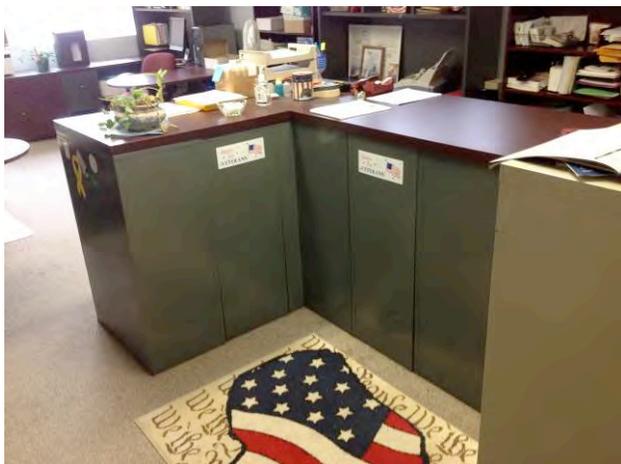
Photo 6

At the Veterans Office on the second floor, a counter exceeds the maximum allowable height for visitors using wheeled mobility devices or who are of short stature. (Photo 6)

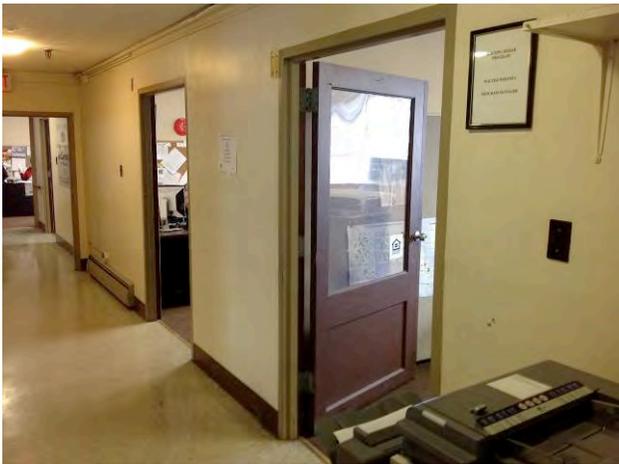
Photo 8

While some signs have been updated in certain areas of the building, the remaining older signage is problematic because not all permanent rooms and spaces are properly identified with ADA-compliant signs. (Photos 8 and 9)

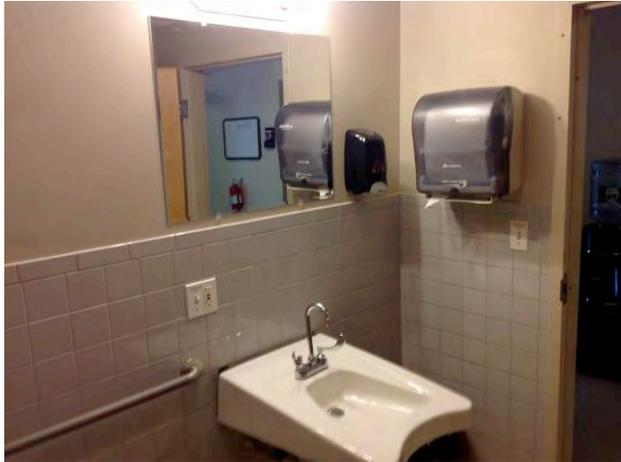
Photo 10

Single-user toilet rooms for staff and public use are located on the first and second floors. In both toilet rooms, plumbing underneath the lavatories is not protected for people using wheeled mobility devices, the toilet and toilet paper dispensers are not correctly placed, and the mirror and wall-mounted accessories (such as soap and paper towel dispensers) exceed the maximum allowable height. (Photo 10)

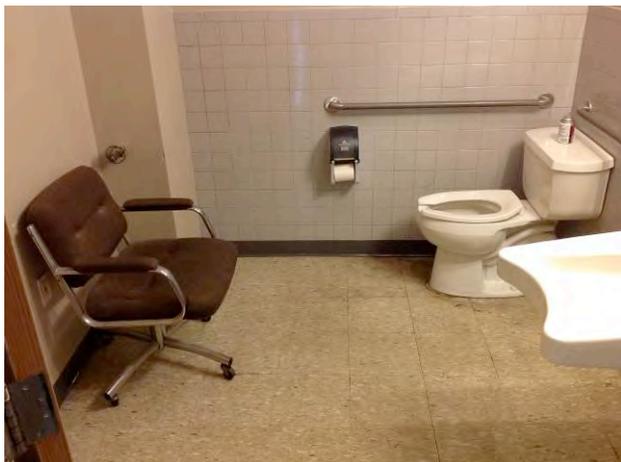
Photo 11

In the toilet room on the second floor, the flush valve is placed at the incorrect side of the toilet and furniture obstructs the maneuvering clearance in the toilet room. (Photo 11)

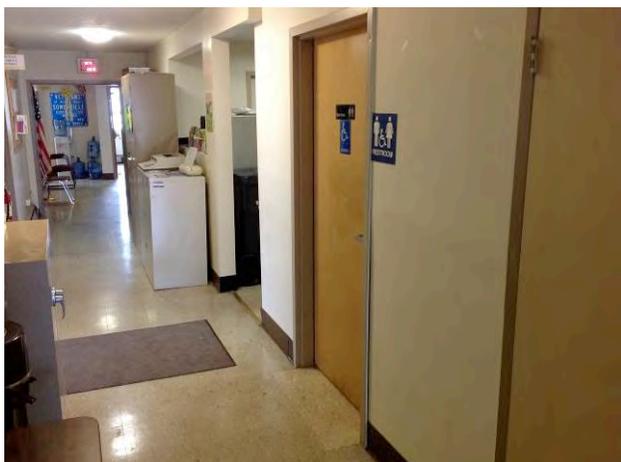
Photo 12

Although non-compliant signs have been installed on the doors of the toilet rooms, all toilet rooms have additional accessible signage. (Photo 12)

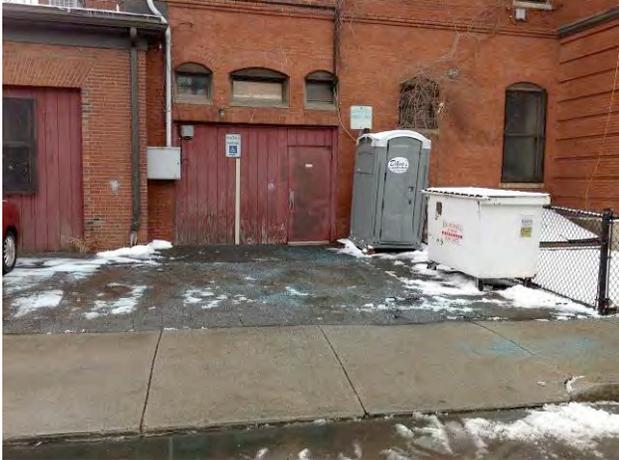
Photo 1

One off-street accessible parking space for public or staff was identified on Cross Street. Not only is the running slope excessive, but also the access aisle and sign for van designated parking are missing. (Photo 1)

1. Provide a 96-inch wide access aisle adjacent to the accessible van space and replace sign.
2. When sidewalks are renovated, re-grade accessible parking space.

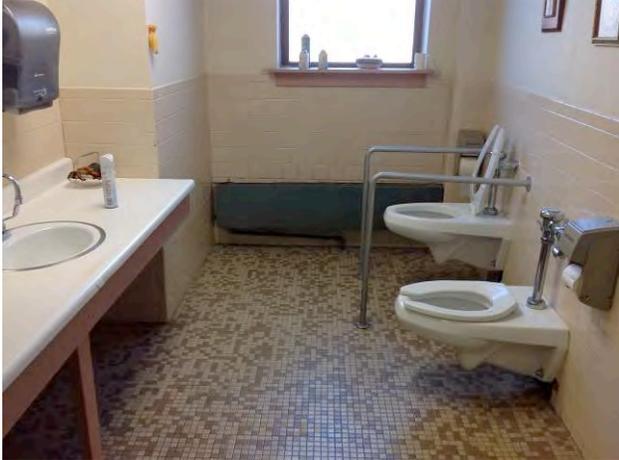
Photo 10

While some signs for toilet rooms have been updated, very little signage is provided at this facility and not all permanent rooms and spaces are properly identified with ADA-compliant signs. (Photo 10)

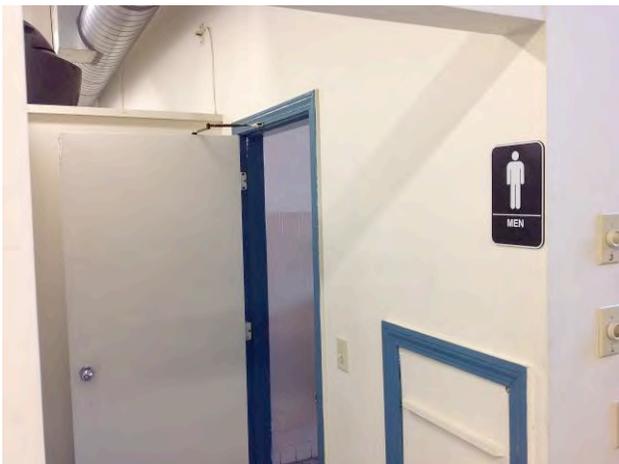
Photo 12

Although compliant signs have been installed near the doors do the toilet rooms inside the Senior Center on the first floor, they are not correctly placed on the latch side of the doors. (Photo 12)

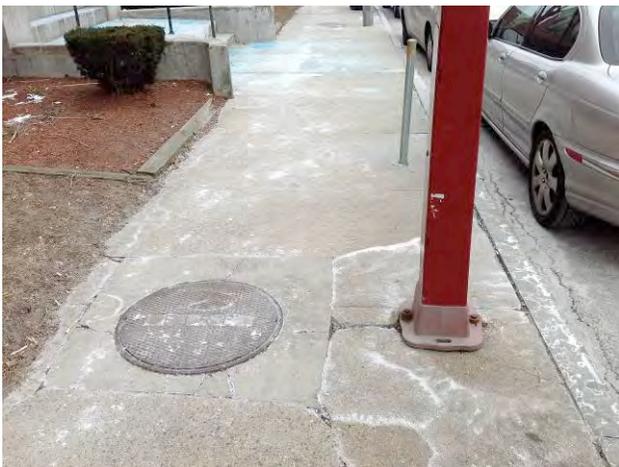
Photo 2

The main entrance to the DPW building is directly connected to the sidewalk along Franey Road. In certain areas of the sidewalk, deteriorated surface can become tripping hazards to the public and staff. (Photo 2)

1. Repair or replace broken or heaved sidewalk panels.

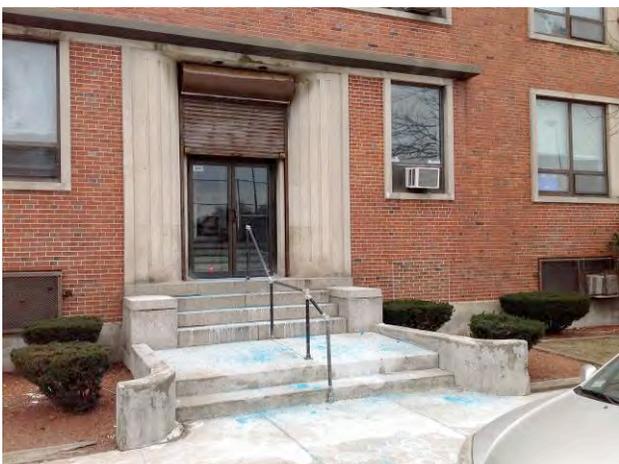
Photo 3

The building has entrances on three sides – in the front on Franey Road, on the side along the driveway, and at the rear along the parking lot. Neither entrance is accessible since stairways with non-compliant handrails are provided to the first floor about six feet above the exterior grade. (Photo 3)

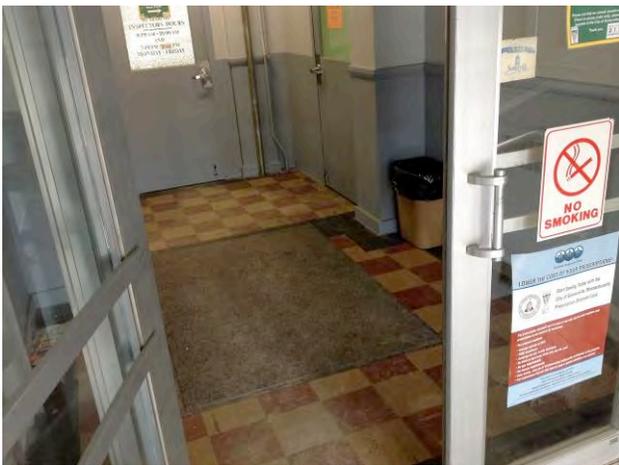
Photo 5

At all entrances as well as other circulation areas within the building, several weather mats are not secure and can become tripping hazards to visitors and staff. (Photo 5)

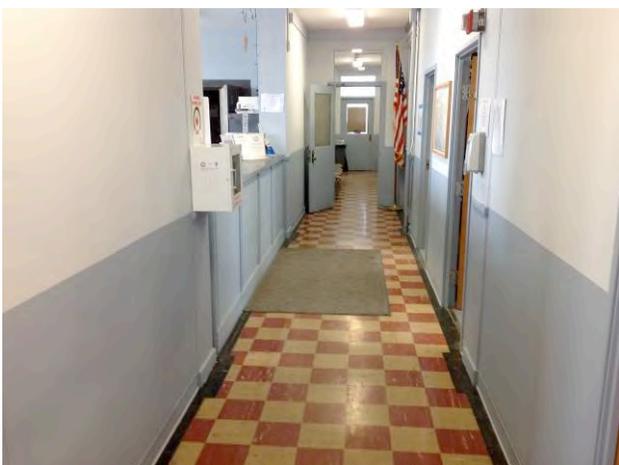
Photo 6

- automatic external defibrillator in the corridor on the second floor; (Photo 6)
- fire extinguisher the corridor in the basement;
- underside of both egress stairways in the basement;
- air conditioner mounted on the window of the Fire Prevention Bureau.

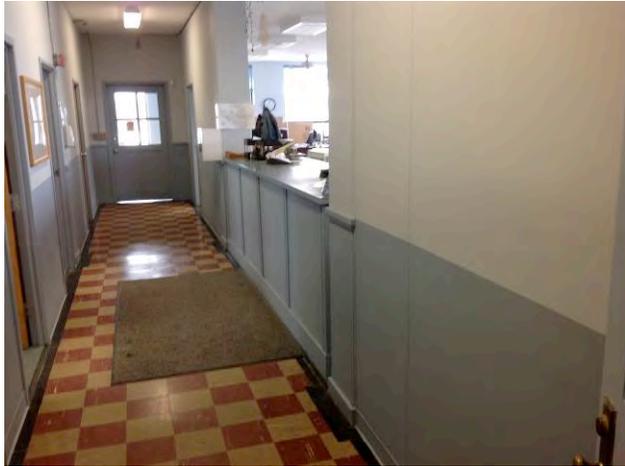
Photo 7

At the Inspectional Services and Engineering Departments on the first floor and Finances Department on the second floor, counters exceed the maximum allowable height for visitors who are of short stature. (Photo 7)

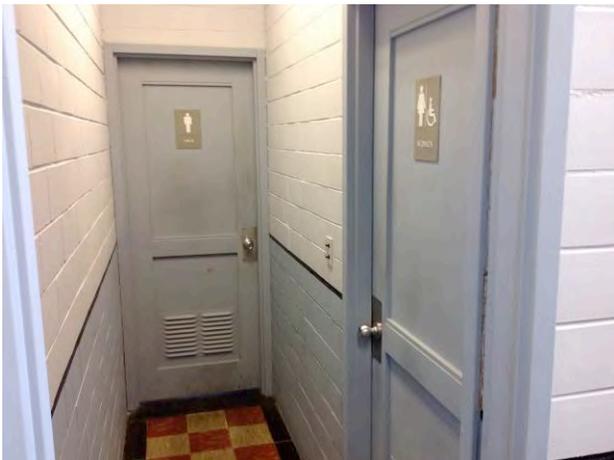
Photo 12

Furthermore, the inaccessible Women's toilet rooms located on the first floor is incorrectly identified with the International Symbol of Accessibility. (Photo 12)

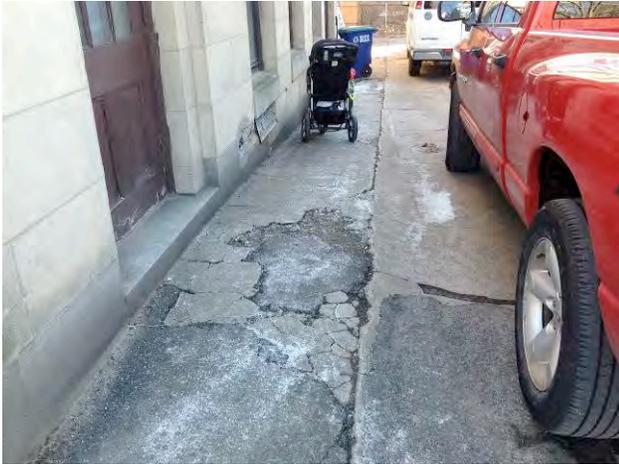
Photo 1

The entrances to the Recreation building are directly connected to the sidewalk along Walnut Street and the driveway. In certain areas of the sidewalk and driveway, deteriorated surface can become tripping hazards to the public and staff. (Photo 1)

1. Repair or replace broken or heaved sidewalk panels.

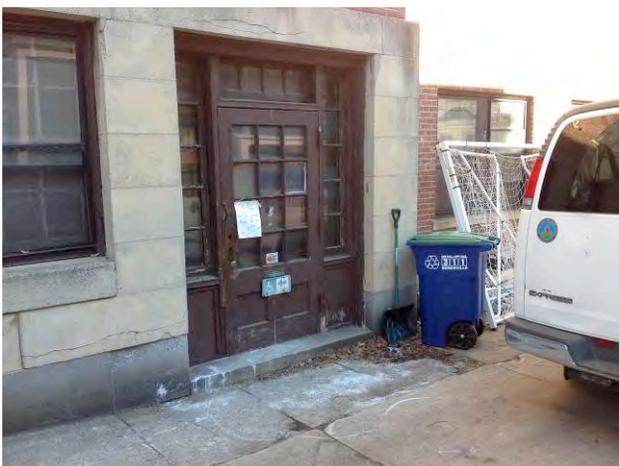
Photo 3

A confusing sign with the International Symbol of Accessibility and arrow directing towards the front entrance is mounted on the side entry door. (Photo 3)

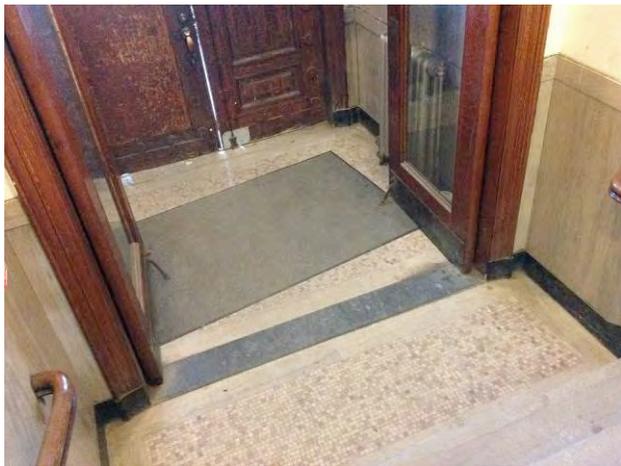
Photo 5

At the main entrance as well as other circulation areas within the first floor, several weather mats are not secure and can become tripping hazards to visitors and staff. (Photo 5)

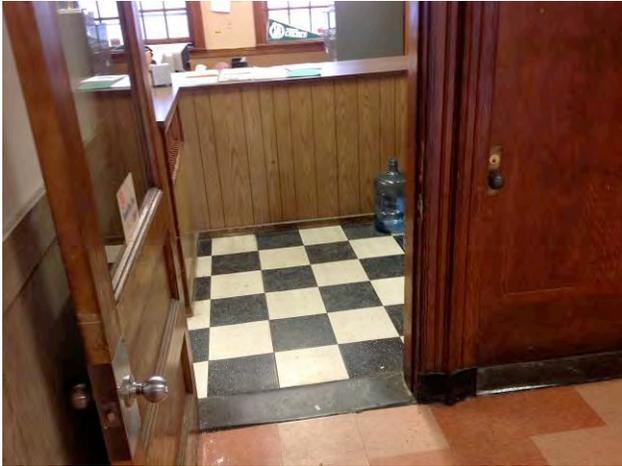
Photo 7

Inside the Recreation Commission office on the first floor, a counter exceeds the maximum allowable height for visitors who are of short stature. (Photo 7)

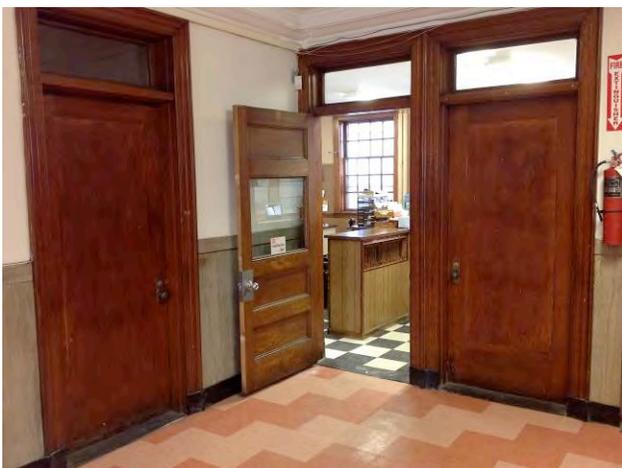
Photo 9

Very little signage is provided at this facility and not all permanent rooms and spaces are properly identified with ADA-compliant signs. (Photo 9)

For additional information, please see Part E – ADA/MAAB References – Scoping Requirements and Communication Elements and Features for Signs. Please also see the Signage and Wayfinding section at the end of this report.

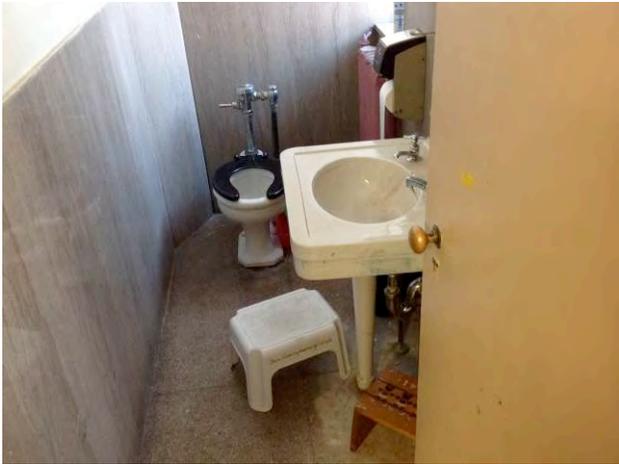
Photo 10

Two single-user toilet rooms for staff and public use are provided at this facility – one on the first floor, the other in the basement. The toilet room on the first floor is completely inaccessible. (Photo 10)

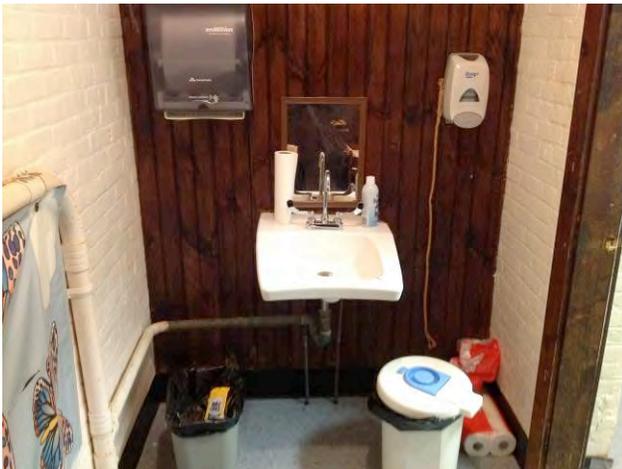
Photo 11

Although the toilet room in the basement offers a few accessible features, plumbing underneath the lavatories is not protected for people using wheeled mobility devices and wall-mounted accessories (such as soap and paper towel dispensers) exceed the maximum allowable height or are obstructed by trash cans. (Photo 11)

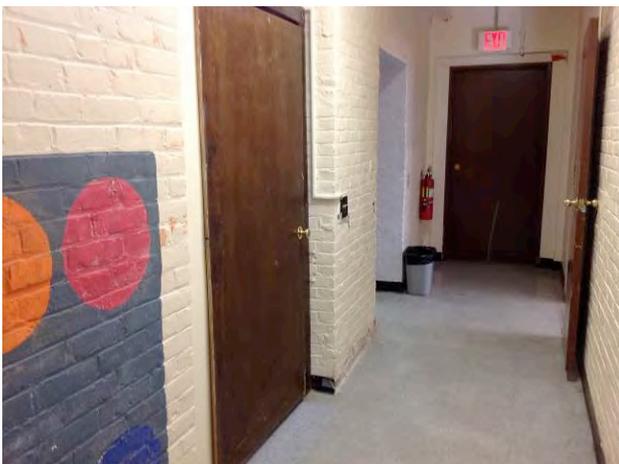
Photo 12

Neither toilet room has any signs to properly identify them. (Photo 12)

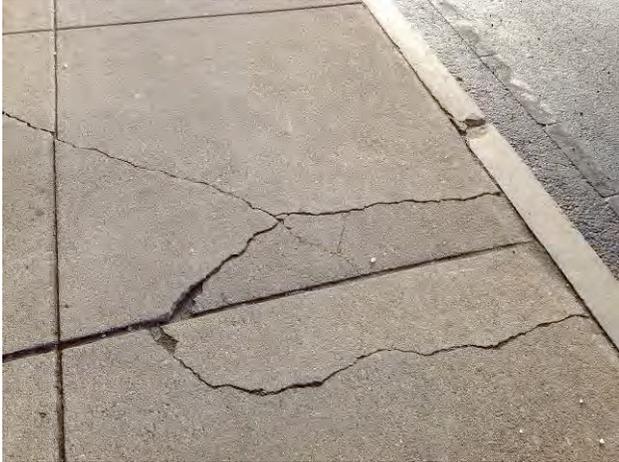
Photo 1

The main entrance to the SCAT building is directly connected to the sidewalks along Somerville Avenue and Prospect Street. In certain areas of the sidewalk, deteriorated surface can become tripping hazards to the public and staff. (Photo 1)

1. Repair or replace broken or heaved sidewalk panels.

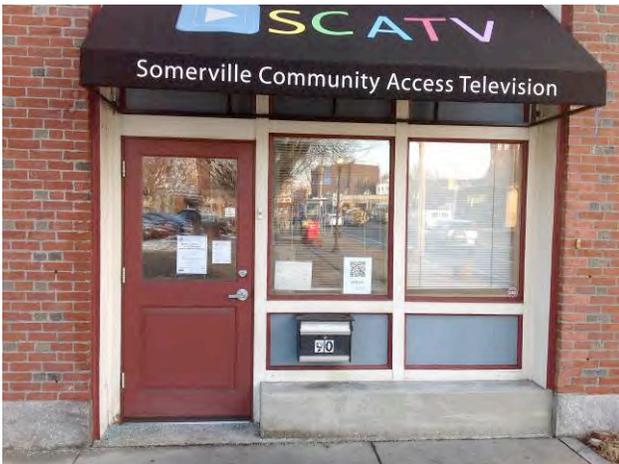
Photo 2

The building has one at-grade entrance between Somerville Avenue and the public parking lot off Prospect Street. Although this entrance may be used by people using wheeled mobility devices, a few issues were identified: the doorbell exceeds the maximum allowable height, the granite threshold is a tripping hazard, and the concrete curb at the edge of the building obstructs the maneuvering clearance of the door. (Photo 2)

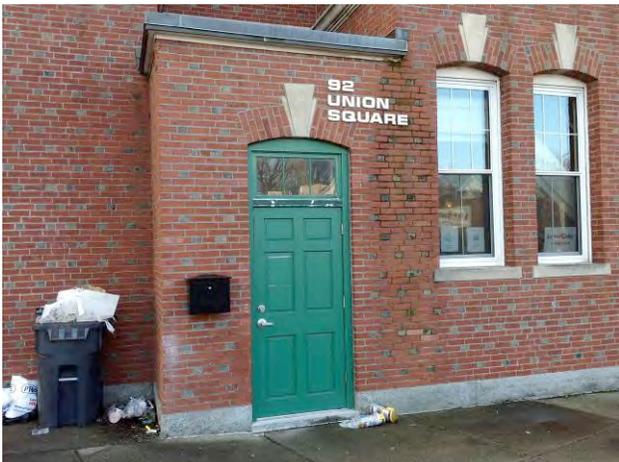
Photo 3

Other doors can be found at other sides of the building, but none of them are located on an accessible route and most connect to stairways. (Photo 3)

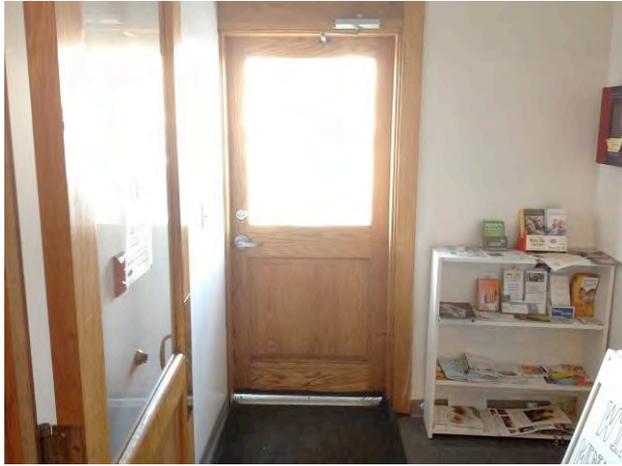
Photo 4

At the entry vestibule, both doors do not have the minimum maneuvering clearance required to open them – the exterior door is obstructed by a wall and the interior doors by a coat rack. (Photos 4 and 5)

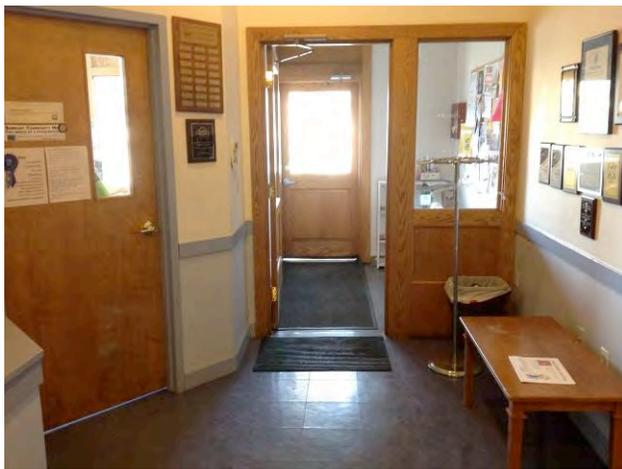
Photo 5

At the entry vestibule, weather mats are not secure and can become tripping hazards to customers and staff. (Photo 5)

1. Secure all weather mats at the entry vestibule with industrial-strength double-stick tape. Alternatively, replace them with recessed walk-off mats or grates.

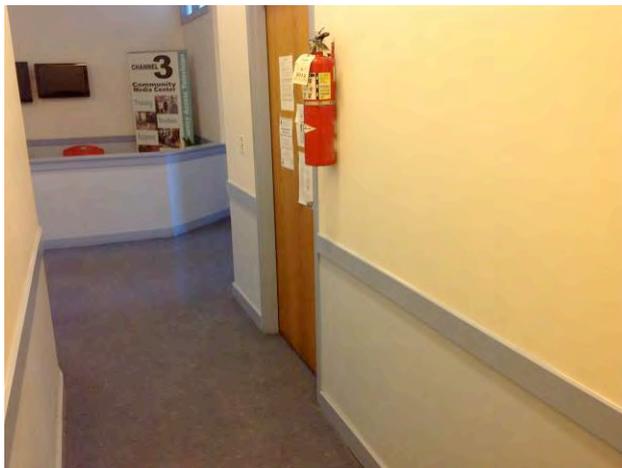
Photo 6

In the corridor near the reception area, a wall-mounted fire extinguisher increases the possibility of injury to customers and staff. (Photo 6)

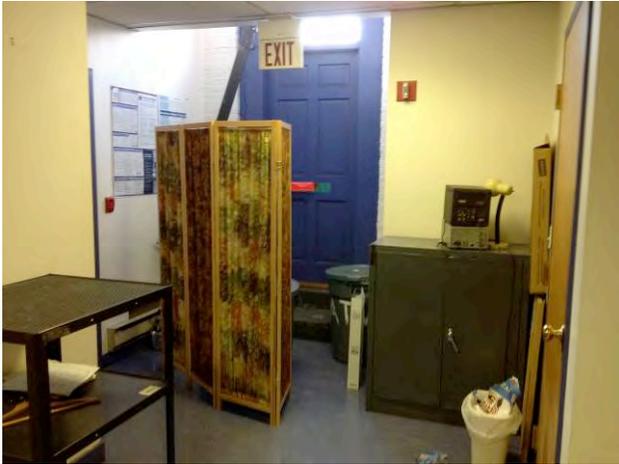
Photo 7

Two stairways can be found away from the building entrance. One stairway leads to an exit door and the other to a classroom about one foot above the first floor. Neither stairway has railings on both sides. (Photos 7 and 8)

1. Install compliant handrails on both sides of the two stairways found away from the building entrance.

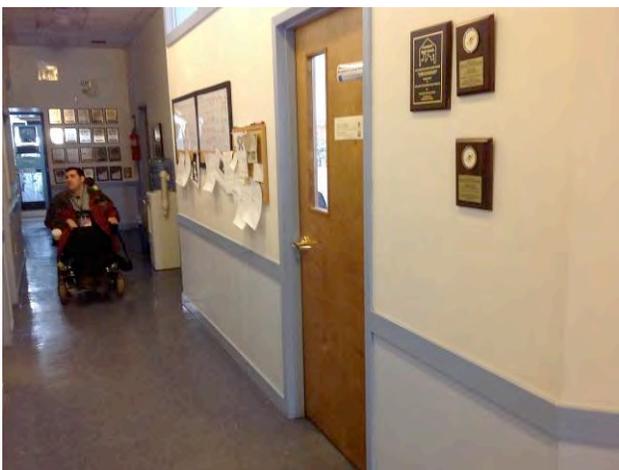
Photo 9

While some signs have been updated in certain areas of the building, the remaining older signage is problematic because not all permanent rooms and spaces are properly identified with ADA-compliant signs. (Photo 9)

For additional information, please see Part E – ADA/MAAB References – Scoping Requirements and Communication Elements and Features for Signs. Please also see the Signage and Wayfinding section at the end of this report.

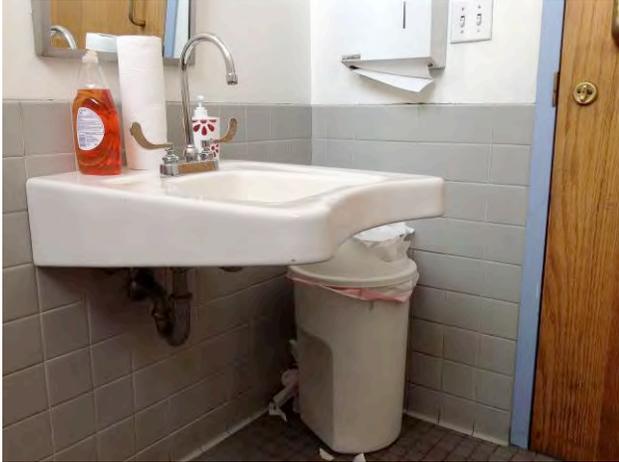
Photo 10

Single-user toilet rooms (one for each gender) for staff and public use are located on the first floor. In both toilet rooms, the lavatory obstructs the minimum maneuvering clearance required to open the door, plumbing underneath the lavatories is not protected for people using wheeled mobility devices. Additionally, mirrors, coat hooks, and wall-mounted accessories (such as soap and paper towel dispensers) exceed the maximum allowable height. (Photo 10)

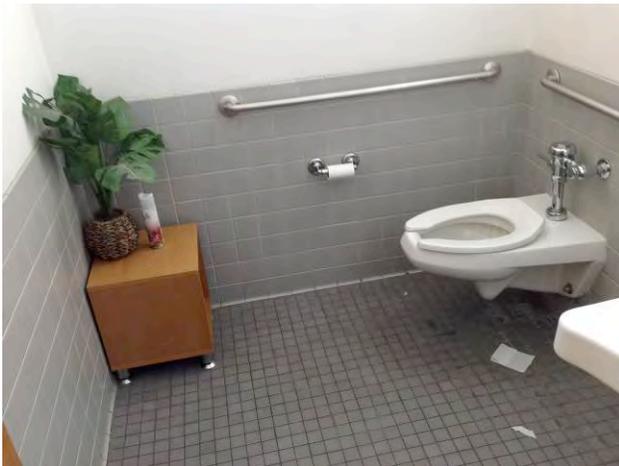
Photo 11

In the Women's toilet room, furniture obstructs the maneuvering clearance in the toilet room. (Photo 11)

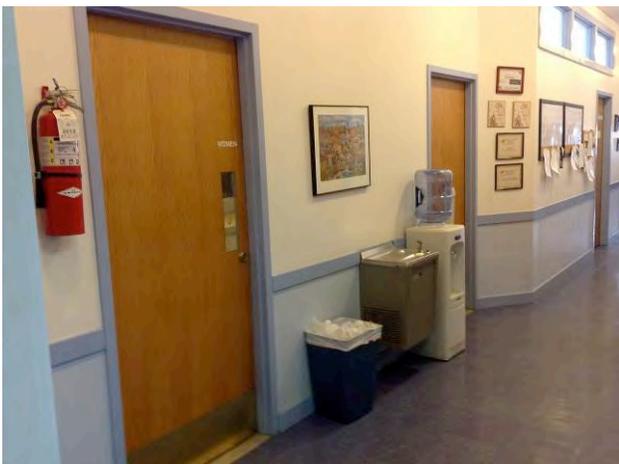
Photo 12

None of the toilet rooms in the building have accessible signage. (Photo 12)

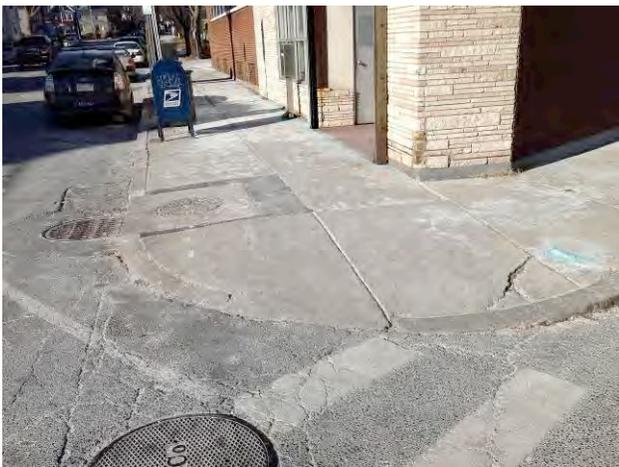
Photo 2

The public entrance to the Traffic & Parking building is directly connected to the sidewalk along Holland and Paulina Streets. In certain areas of the sidewalk, deteriorated surface can become tripping hazards to the public and staff. (Photo 2)

1. Repair or replace broken or heaved sidewalk panels.

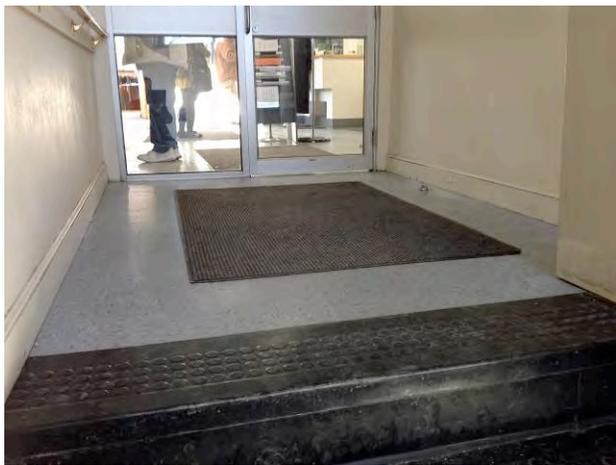
Photo 5

At the public entrance as well as the lobby and other circulation areas within the building, several weather mats are not secure and can become tripping hazards to customers and staff. (Photo 5)

1. Secure all weather mats with industrial-strength double-stick tape. Alternatively, replace them with recessed walk-off mats or grates.

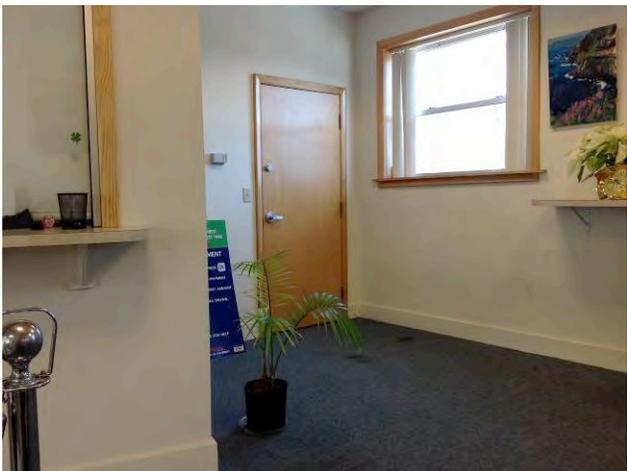
Photo 9

While some signs have been updated in certain areas of the building, the remaining older signage is problematic because not all permanent rooms and spaces are properly identified with ADA-compliant signs. (Photo 9)

For additional information, please see Part E – ADA/MAAB References – Scoping Requirements and Communication Elements and Features for Signs. Please also see the Signage and Wayfinding section at the end of this report.

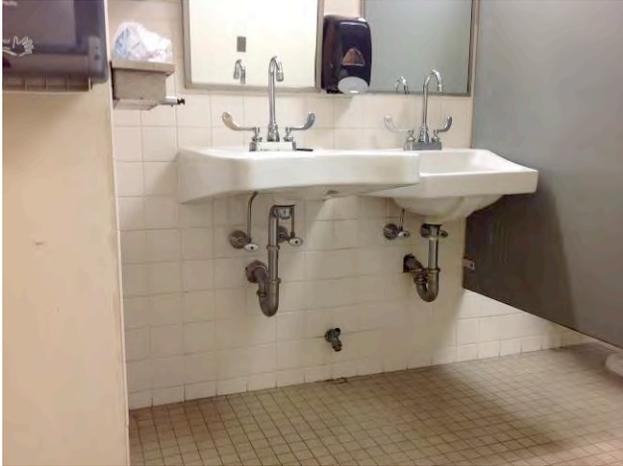
Photo 10

No toilet rooms for public use are provided in the public area of this facility. Toilet rooms for staff use located near the service entrance are mostly accessible. In both toilet rooms, plumbing underneath the lavatories is not protected for people using wheeled mobility devices and the toilet paper dispensers inside the toilet stalls are not correctly placed. Additionally, in the Men's toilet room, the flush valve is placed at the incorrect side of the toilet and the side grab bar is not mounted on a coplanar surface. (Photos 10 & 11)

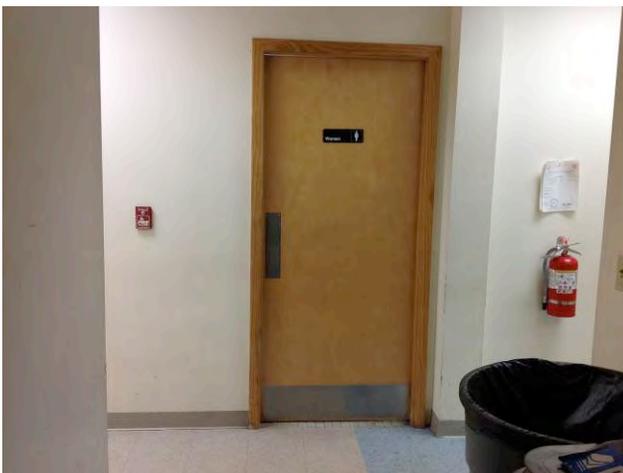
Photo 12

Although signs have been installed on the doors of the toilet rooms for staff use, none of the toilet rooms have accessible signage. (Photo 12)

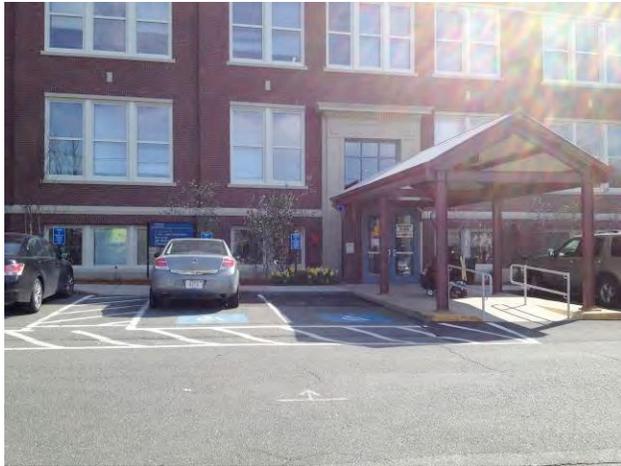
Photo 1

Although five accessible parking spaces were identified, the closest one to the entrance is missing the required access aisle. Additionally, one designated van parking space was not identified in this facility. (Photo 1)

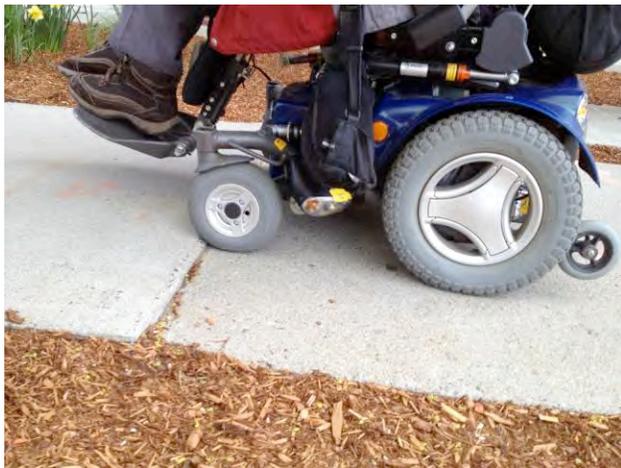
Photo 2

The public entrance to the Tufts Administration Building is directly connected to the sidewalk along Holland Street and walkways along the parking lot. In certain areas of the walkway, deteriorated surface can become tripping hazards to the public and staff. Additionally, curb ramps without a level landing at the top and parked vehicles obstruct the minimum clear width of the accessible route to the entrance. (Photos 2 and 3)

1. Repair or replace all degraded walking surfaces, including the concrete walkways and brick walkway near the entrance.
2. Replace curb ramps adjacent to parking.

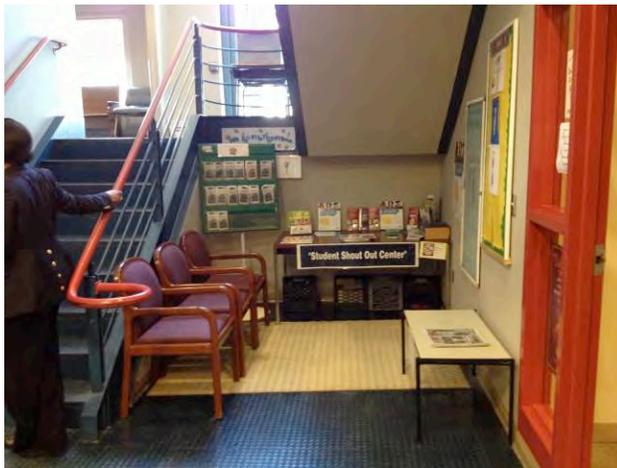
Photo 5

- overhead signs along the corridors serving SCALE on the first floor;
- underside of the interior stairway on the first floor. (Photo 5)

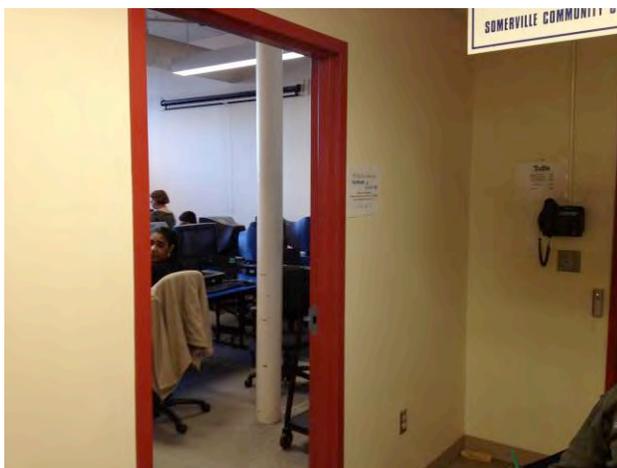
Photo 6

While numerous signs have been updated in most areas of the building, not all permanent rooms and spaces are properly identified with ADA-compliant signs. (Photo 6)

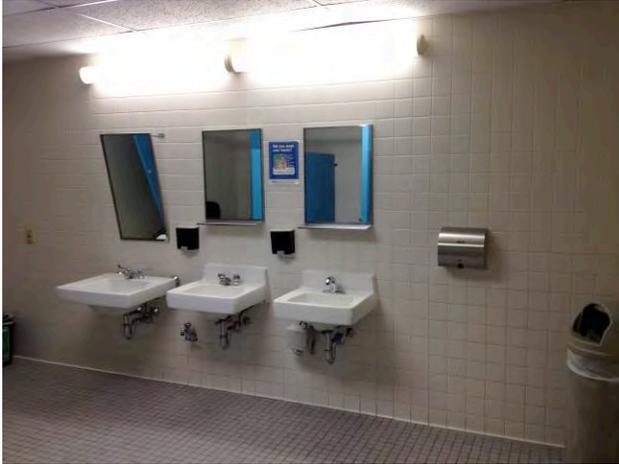
Photo 10

One set of multi-user toilet rooms (one or each gender) for public and staff use are provided on the first and second floors. In all toilet rooms, plumbing underneath the lavatories is not protected for people using wheeled mobility devices and grab bars inside accessible stalls do not meet the minimum allowable height. (Photos 10 & 11)

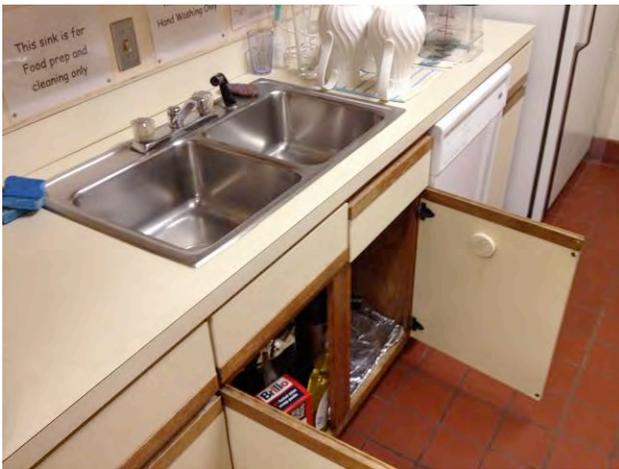
Photo 14

The kitchenette on the second floor has not been renovated and lacks clear floor space and an accessible sink, among other items. (Photo 14)

1. Short Term: Ensure policies are developed to address employee accommodation requests.
2. Long Term: As kitchenettes are replaced, ensure that replacements meet all ADA/MAAB requirements.

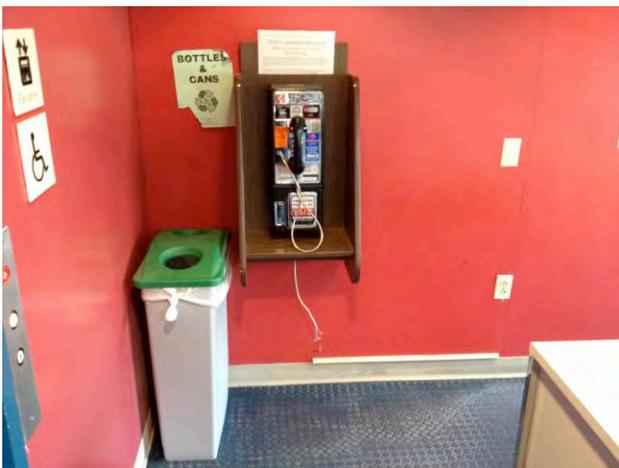
Photo 15

At the entry lobby, a public pay phone lacks signage indicating availability of TDD/TTY, nor was a TDD/TTY found. (Photo 15)

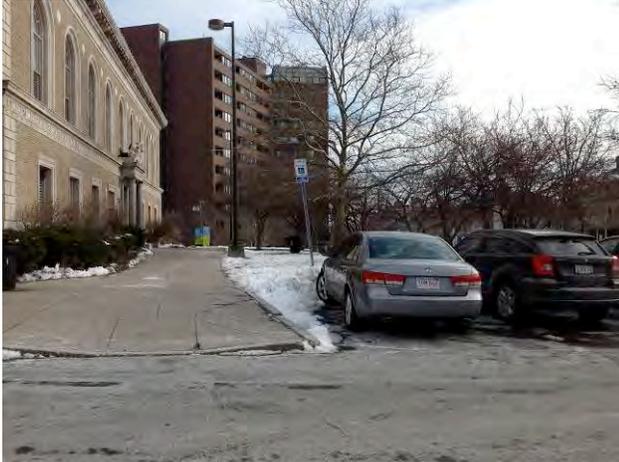
Photo 1

Off-street staff and public parking was identified in parking lot adjacent to the building. Although one accessible van parking space for public is provided near the entrance, the required access aisle is missing. (Photo 1)
